# Severe Weather Outbreak

June 27<sup>th</sup>, 2011

## Two EF1 Tornado Tracks In Shelbina (Shelby County, Missouri)

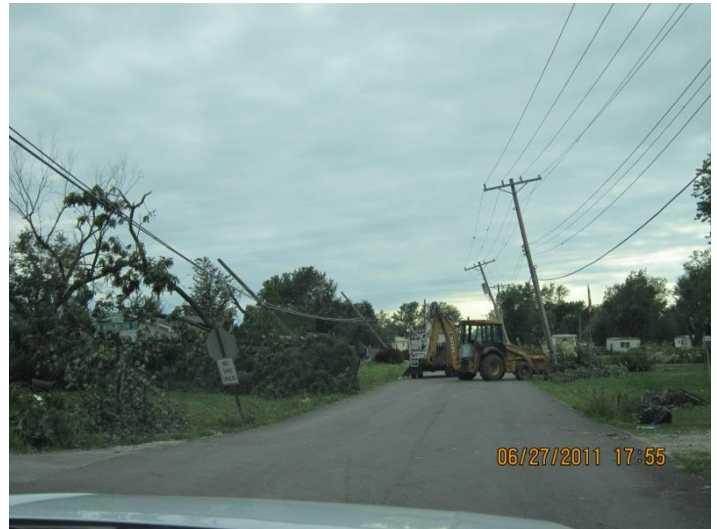
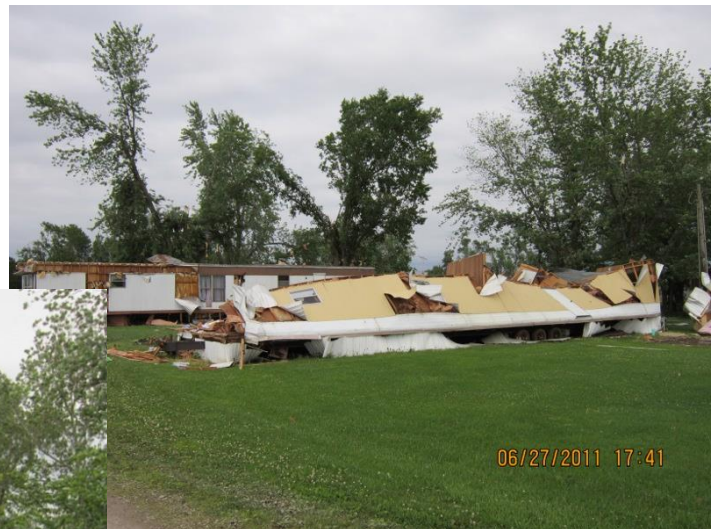
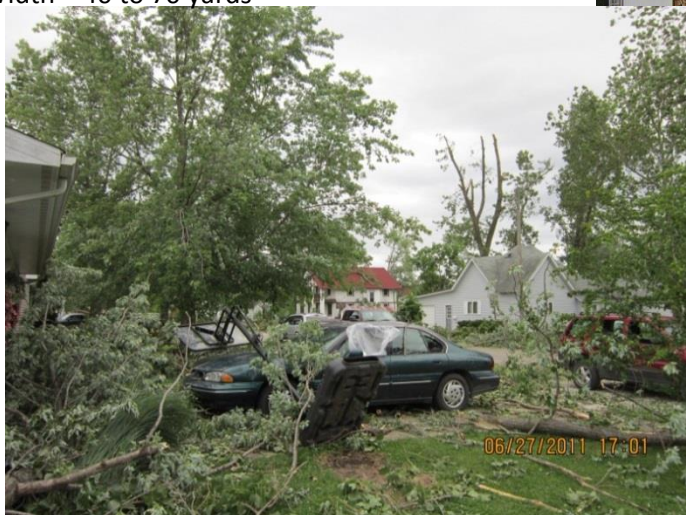
The first tornado formed near Elm Street and Douglas Avenue, north of U.S. Highway 36 at approximately 1255 AM CDT. The roof and walls of a corrugated steel building buckled on the west and south sides, along with a portion of the roof. The tornado moved across U.S. Highway 36 and destroyed three unoccupied house trailers. Debris was tossed about 100 yards from the trailers. The tornado continued to move east-southeast and caused roof damage to the town power and water plants on Chestnut Street west of Shelby Street. A portion of the gables holding the roof of the power plant was uplifted and tossed approximately 50 yards to the east. Much of the water plant's roof was removed and tossed 40 to 50 yard to the east. The tornado then caused minor roof damage on homes and snapped numerous large trees about 10 to 20 feet from the base. Some of the large branches fell on top of vehicles. The tornado then caused extensive damage to the roof of the two story town museum on Center Street (Highway 15). Several bricks fell to the ground from the top of the museum roof. Additional tree damage was found east and southeast of the town museum building.

Damage Rating = EF1 (Peak wind speeds of 105 mph)  
Track Length = 1.2 miles  
Damage Width = 50 to 70 yards

The second tornado damage track was just to the south of the first tornado. It began west of South Center Street, where significant tree damage occurred. Some of the trees fell on top of homes. The tornado traveled east-southeast and hit an assisted living home on Shelbina Avenue. Roof damage was found at this location. Other large trees were damaged in the vicinity of the assisted living home. The tornado continued to the east-southeast and destroyed a large machine shed built in 2008. The east, south and west sides and the roof of the machine shed were tossed into several corn fields. The tornado then crossed County Road 441, where it hit a tree line with several trees snapped 15 to 20 feet from the base and tree trunk diameters ranging from 1 to 2.5 feet. The width of the damage in this area was 50 yards.

Damage Rating = EF1 (Peak wind speeds of 100 mph)  
Track Length = 1.2 miles  
Damage Width = 40 to 70 yards
